## Polycarbonate Headlamp Surface Repair

Edition: October 2017, Opel Automobile GmbH, Rüsselsheim am Main

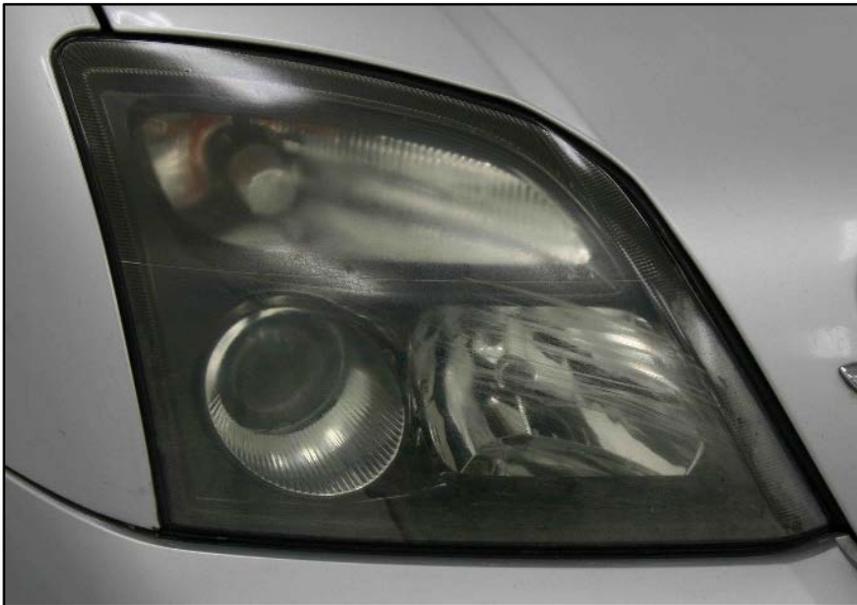
polycarbonate headlamp  
with scratches and yellowing

- before repair

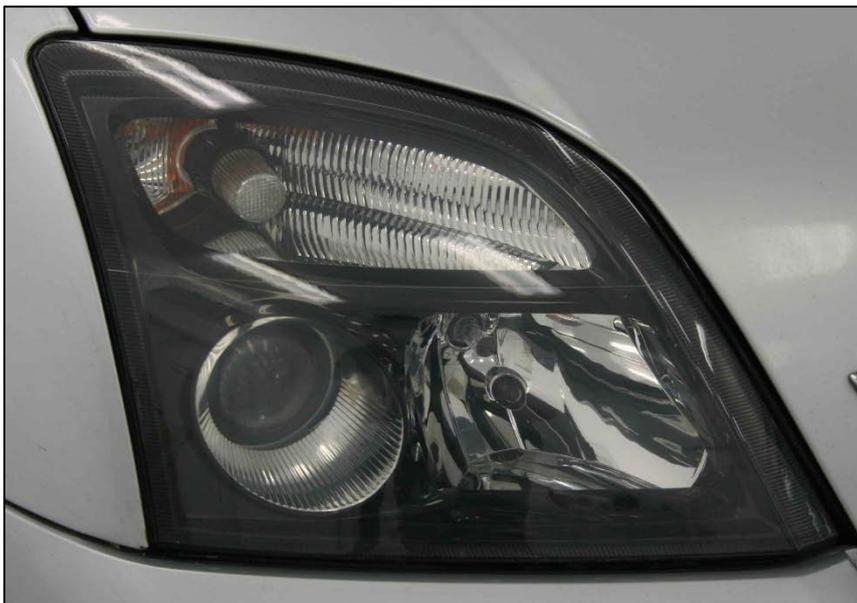
polycarbonate headlamp

- after repair

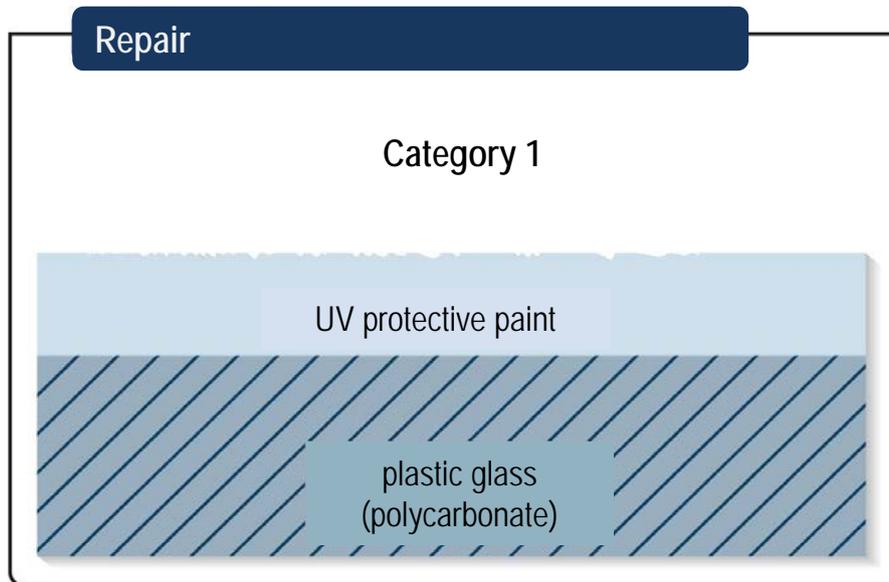
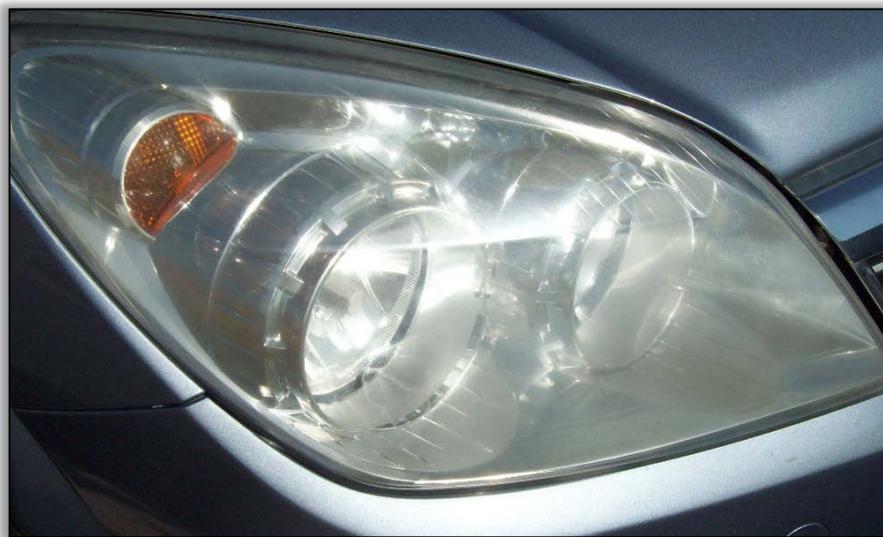
## Category 1:

Surface yellowed or matted due to environmental influence and sunlight

Yellowing

Completely remove the UV protective paint by sanding and re-coat according to repair set handling instruction.

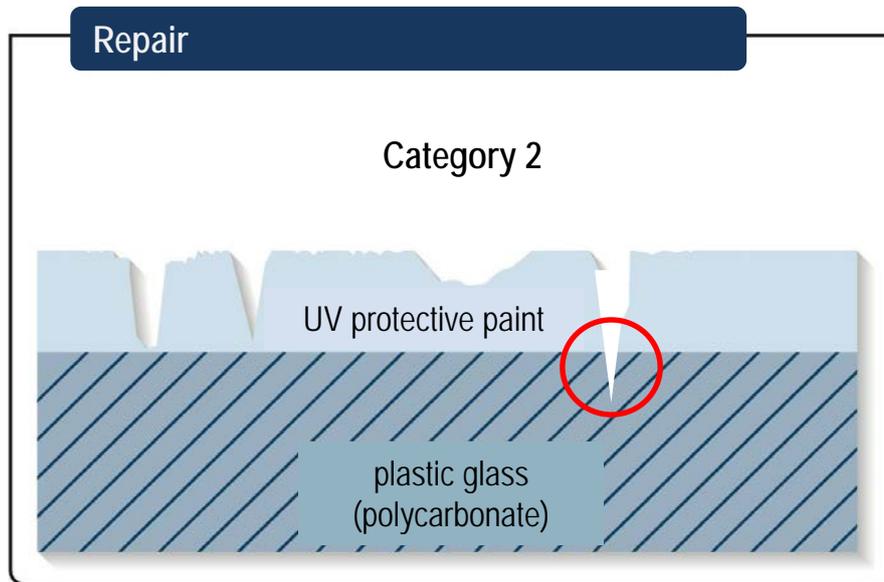
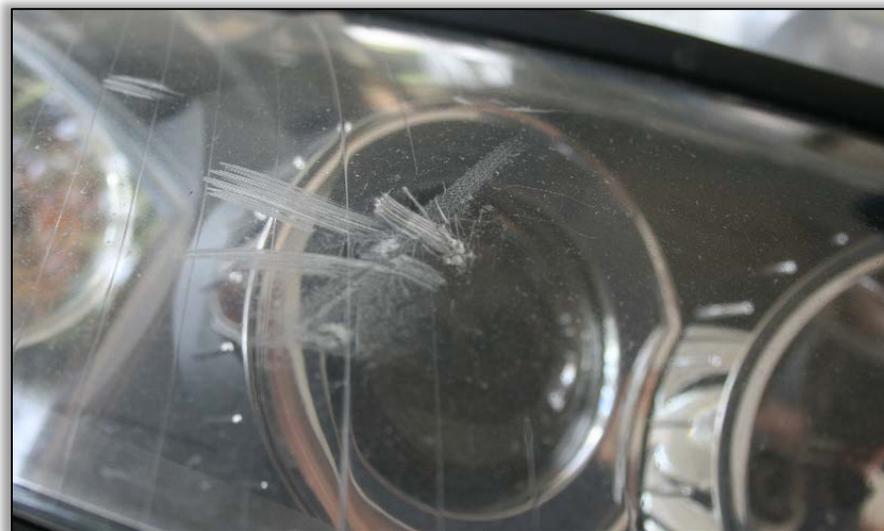
## Category 2:

Slight scratches / stone-chipping in the UV protective paint, deep scratches infiltrating the polycarbonate

Scratches infiltrating the polycarbonate

Completely remove the UV protective paint by sanding and inspect the damaged spot. Deep scratches and stone-chipping have to be grinded extensively and steadily. Re-coat according to repair set handling instruction.

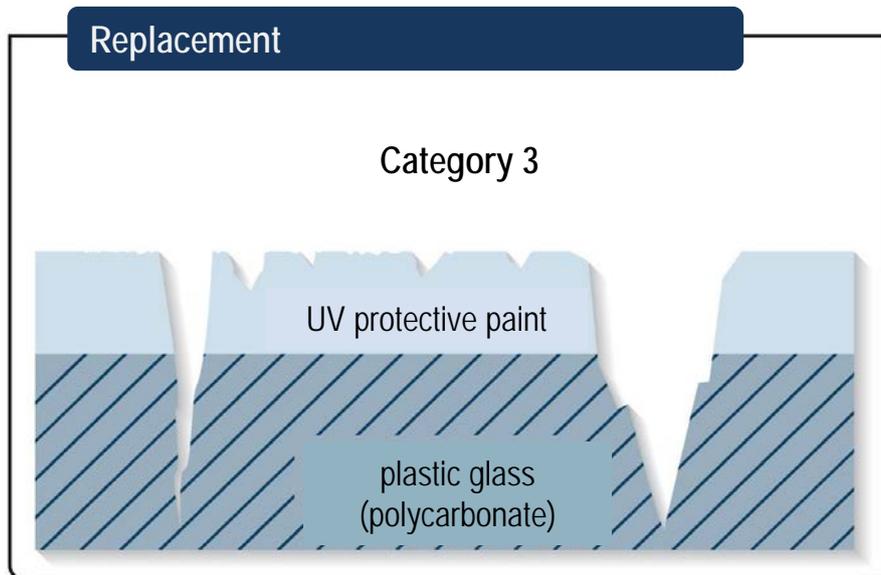
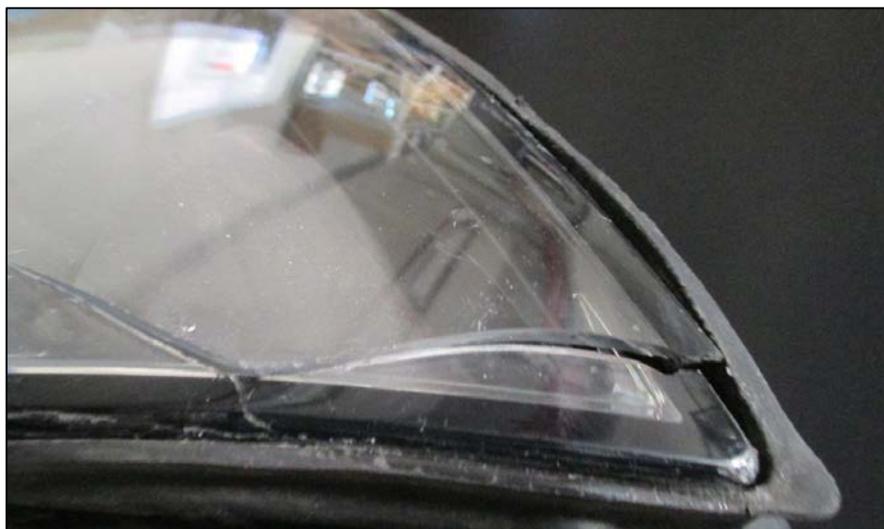
## Category 3:

Deformation, cracks, holes, fracture in the plastic glass

Fracture of the glass

These damages are not repairable.

**The complete headlamp has to be replaced.**
