## Polycarbonate Headlamp Surface Repair

Edition: October 2017, Opel Automobile GmbH, Rüsselsheim am Main

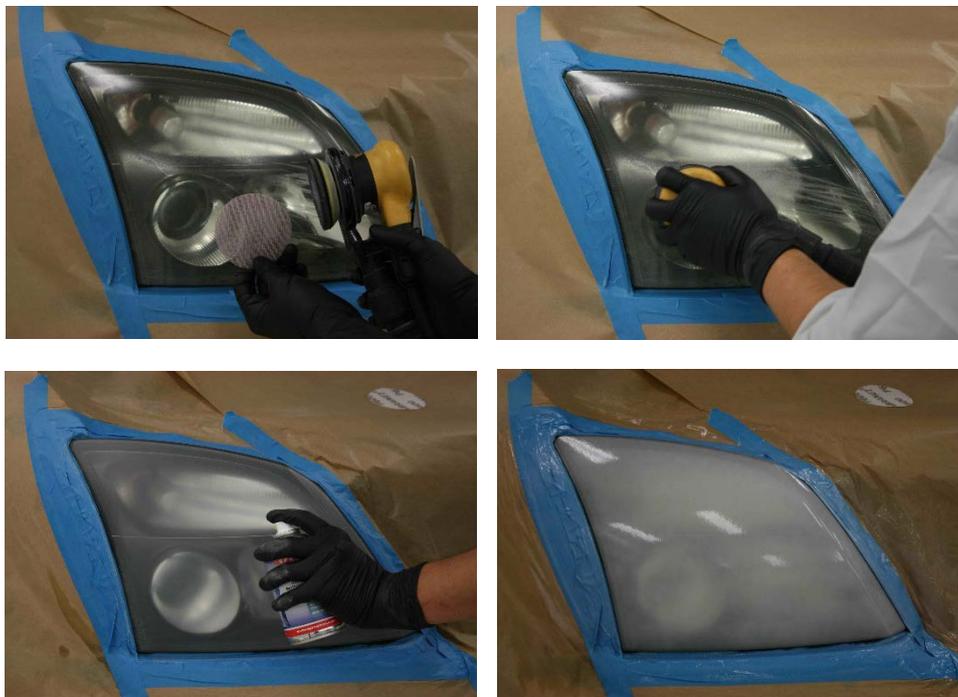
The primer is **completely dry** when the painted coat is slightly opaque (hazy), but **not** milky / white anymore.

Dry approximately 30 minutes at a **room temperature of 20°C**. The drying process of the primer can be sped up by an air circulation (max. 40°C) in a professional varnishing cabin.
